# APPENDIX G

Technical Memorandum

## Rail Assessment and Recommendations

January 2022

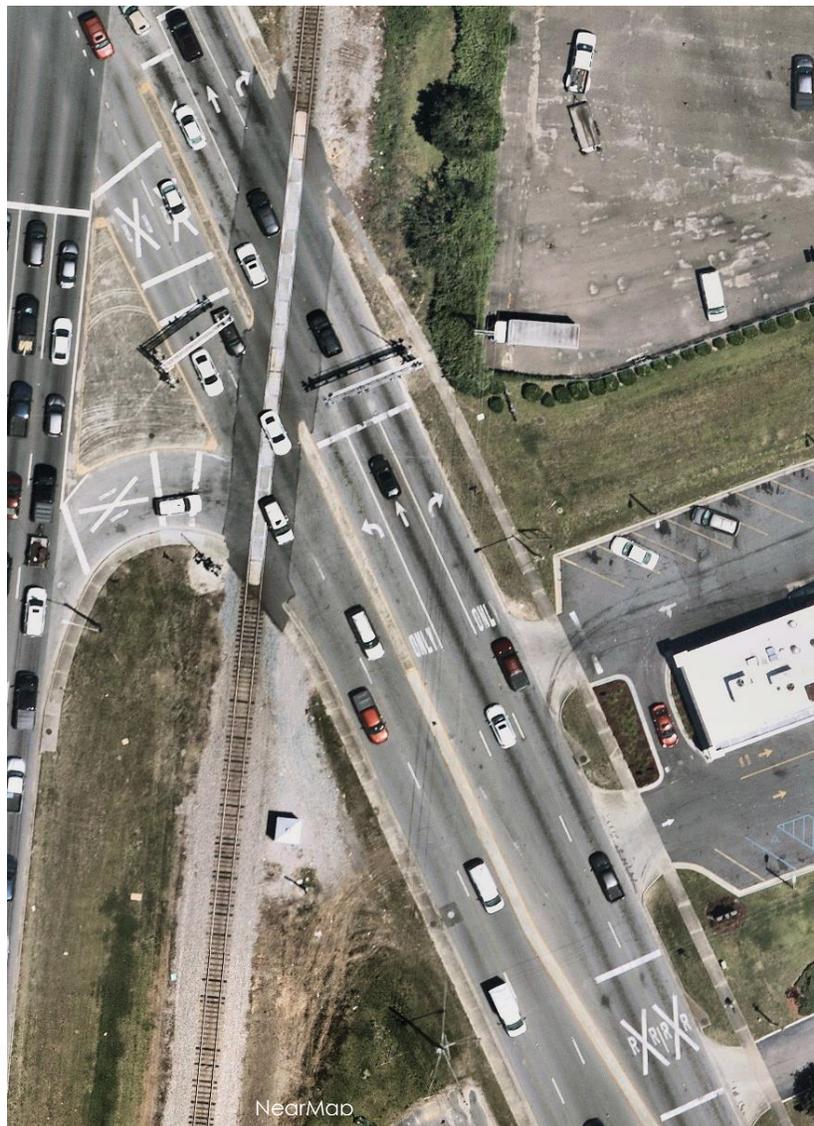
**Figure 20 - Red Bank Road Crossing Pavement Markings**

*Railroad Crossing Pavement Markings (Poor Condition):* Pavement markings are present for all crossing approaches but are cracking and scaling off. Nighttime visibility may be impacted from the deteriorated condition.

- Replace south sidewalk with ADA compliant concrete sidewalk;
- Install pre-emption with intersection signals to clear queue for train arrival;
- Remove and replace stop bar and railroad crossing pavement markings;
- Install pedestrian gates at open sidewalks in three locations;
- Improve existing signal system for additional gates; and
- Install detectable warning pads for all sidewalk approaches.

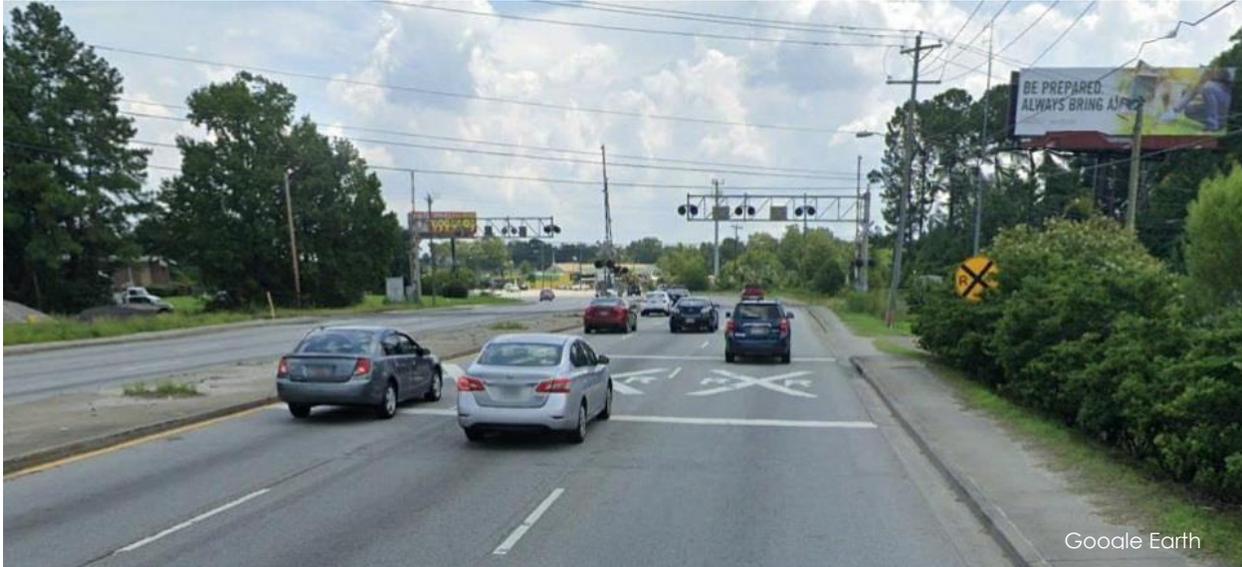
**Figure 23 - Ashley Phosphate Road - Looking East (1)**

*Railroad Crossing Signs (Fair Condition)*: Advance crossing warning signs are present for both Ashley Phosphate Road approaches. The west approach advance warning appears to be overgrown by adjacent trees (Figure 23). There is no advance warning sign present on Southrail Road.

- Install Queue Cutter Signal with Crossing Preemption for westbound roadway;
- Install pedestrian gates in open quadrants;
- Improve existing system for additional gates;
- Remove vegetation around west approach advance warning sign;
- Remove and replace southwest sidewalk at crossing; and
- Remove remaining detectable warning pads and install new pads.

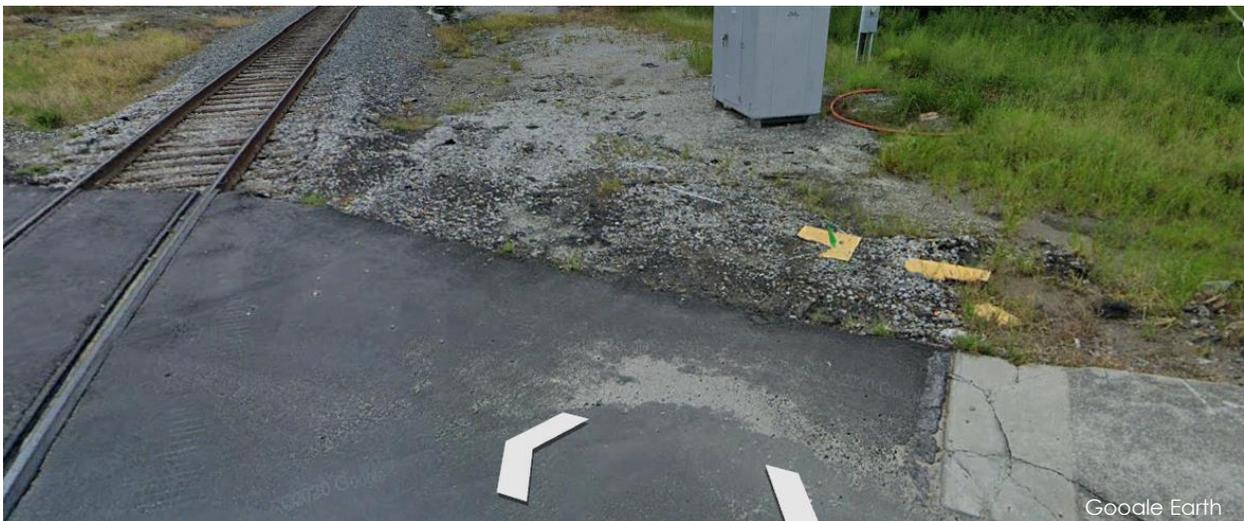
**Figure 30 - Ashley Phosphate Crossing Detectable Warning Pad SW quadrant**

*Pedestrian Access and Curbing (Fair Condition):* Sidewalk is present with mountable curbing on both sides of each approach, with smooth transitions to the crossing surface. The 2020 street view images show that the southwest quadrant detectable warning pad has separated completely from the deteriorated sidewalk (Figure 30), and vegetation is beginning to overgrow the sidewalk approach.

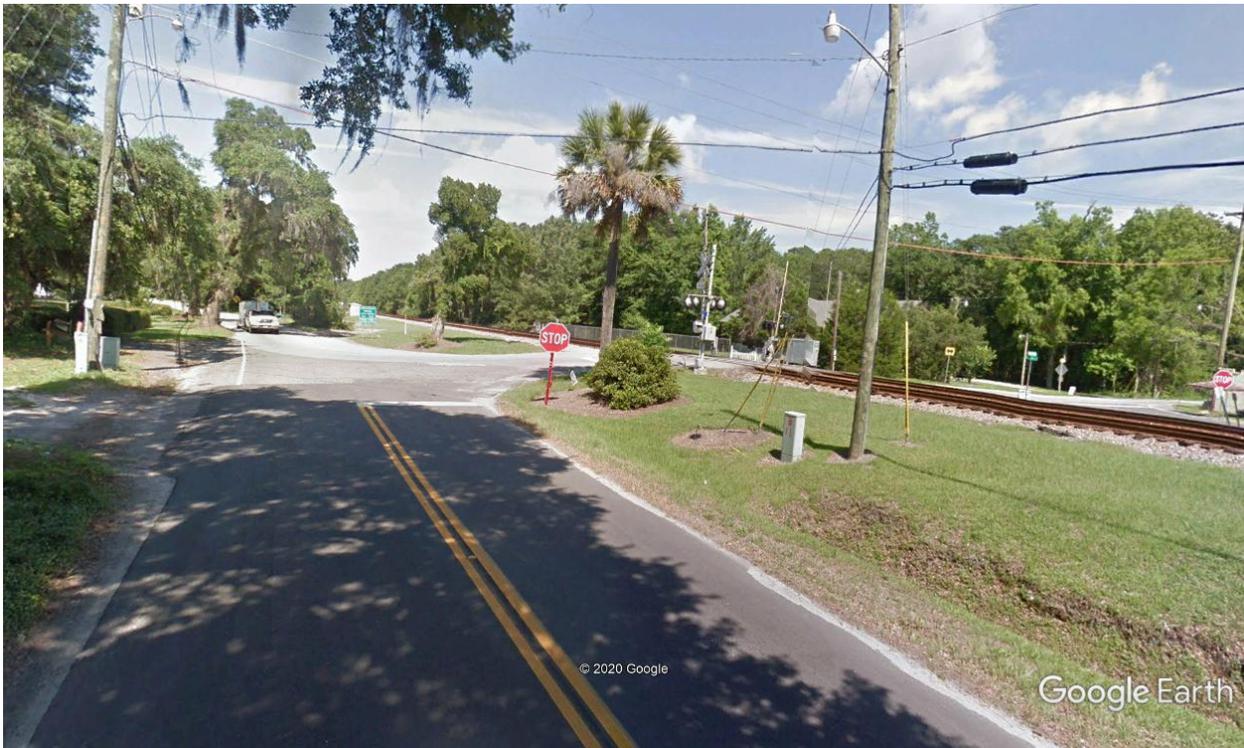
**Figure 33 - Drayton Street East Approach to Crossing Looking West**

*Railroad Crossing Pavement Markings (Poor Condition):* Stop bars and railroad crossing pavement markings appear to be in poor condition with cracking and deterioration (See Figure 36 & Figure 38). Advance warning pavement markings are not present on east approach of Drayton Street and Martin Street (See Figure 33 & Figure 40).
