# APPENDIX G

Technical Memorandum

## Rail Assessment and Recommendations

January 2022

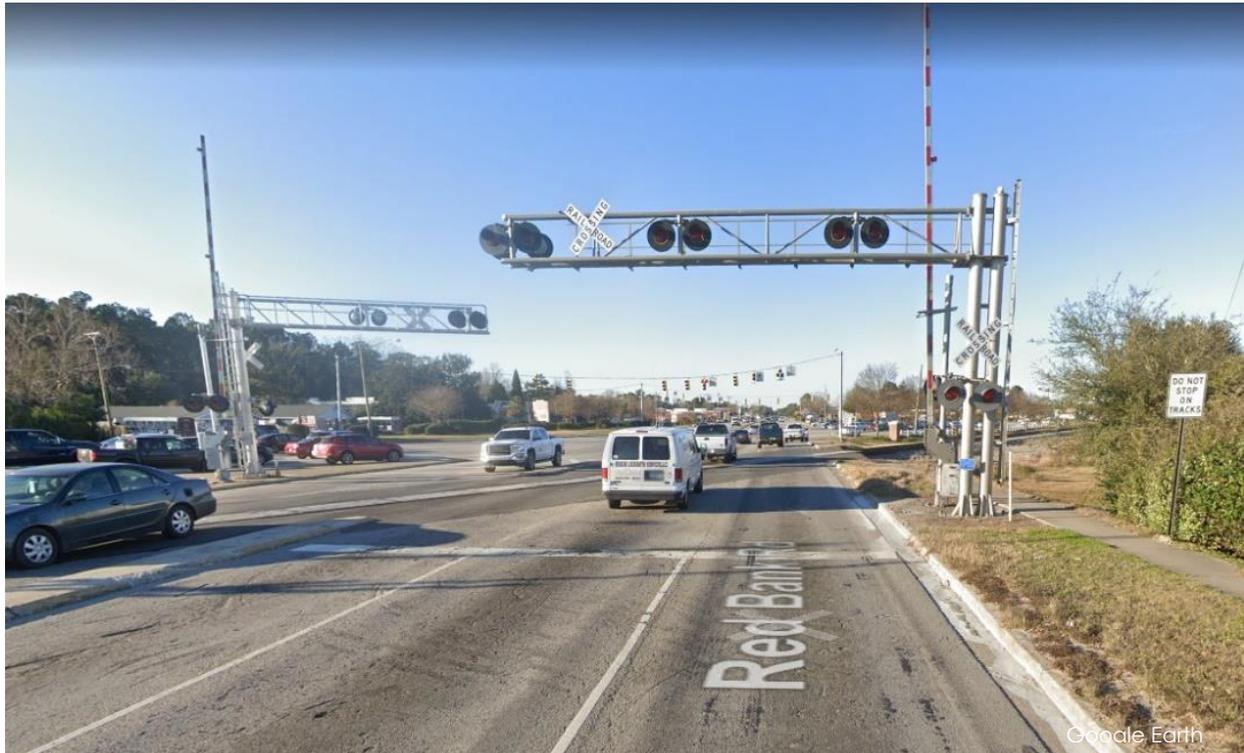
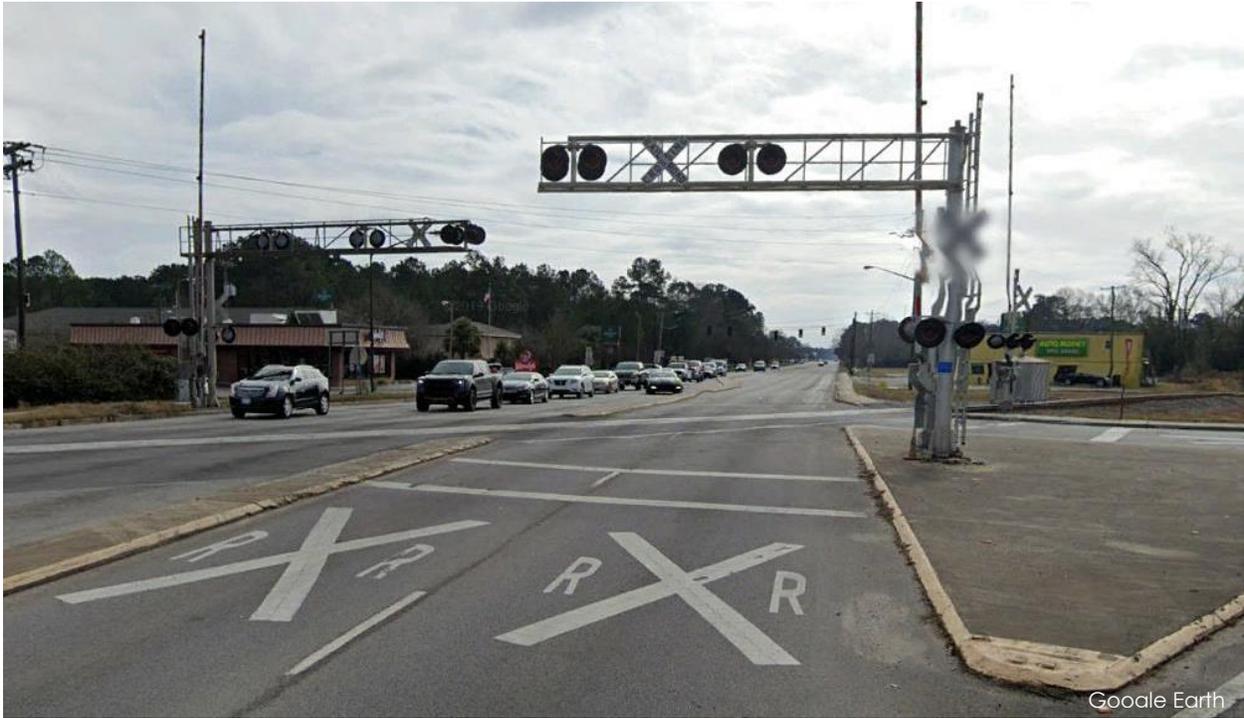
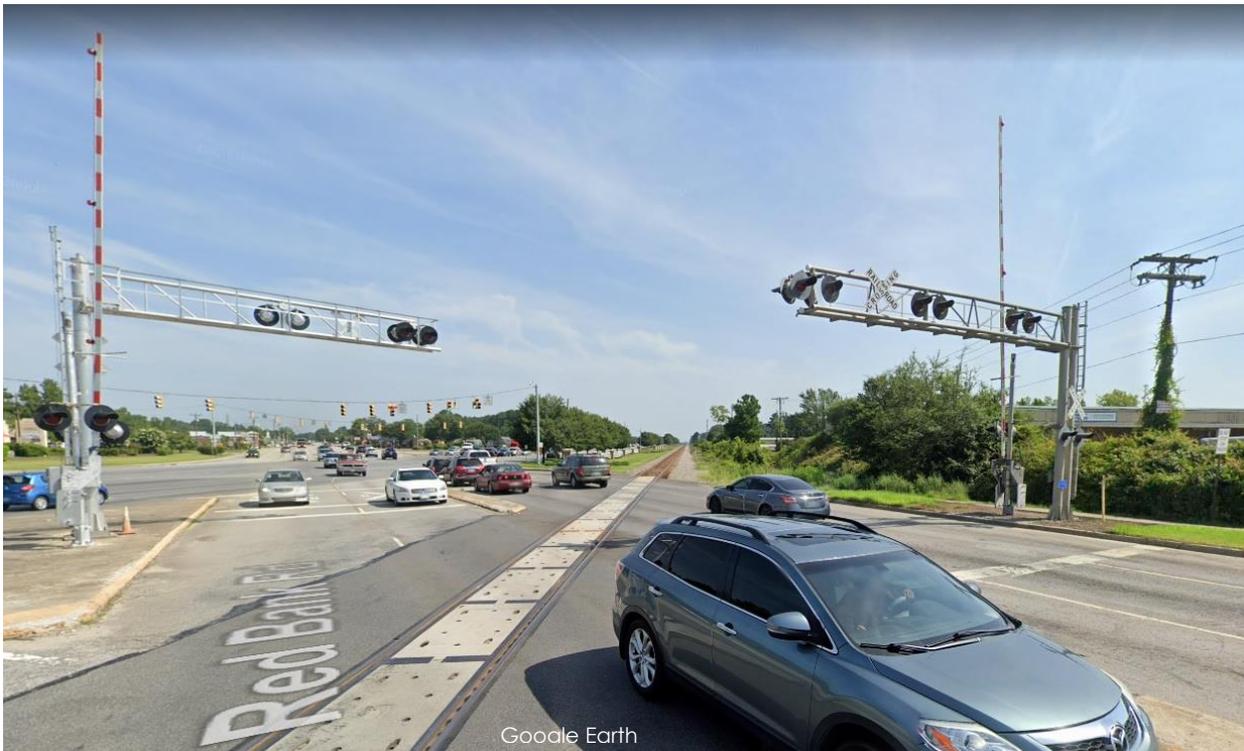
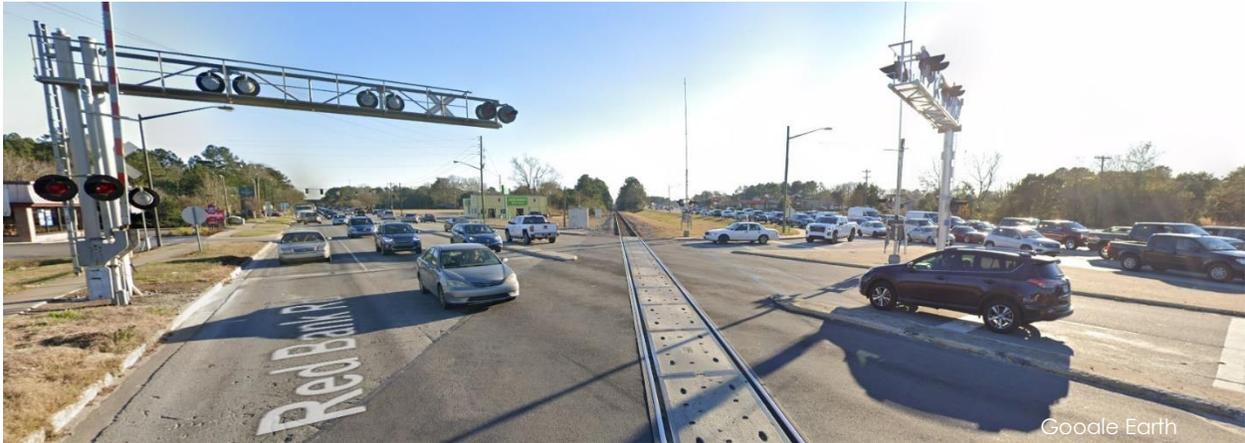
*Crossing Signal Equipment (Good Condition):* Two quadrant protection and cantilever signal masts for Red Bank Road; gate protection for on-coming traffic protection for the S Goose Creek northbound turn lane. Gates are noticeably long and only located at the edge of roadway. Sidewalks are not protected in remaining quadrants.

*Roadway Surface (Good Condition):* Crossing surface consists of concrete gauge panels with flangeway filler outside the rails, notably repaved recently as part of a railroad improvement project for this crossing. Approach pavement appears to be in good condition. Red Bank Road has narrow medians on each crossing approach that appear to be mountable.

*Railroad Crossing Signs (Good Condition):* The Red Bank Road northbound approach and S Goose Creek Boulevard northbound turn lane both have clear passive warning signs.

*Railroad Crossing Pavement Markings (Poor Condition):* Pavement markings are present for all crossing approaches but are cracking and scaling off. Nighttime visibility may be impacted from the deteriorated condition.

*Drainage (Good Condition):* No apparent drainage issues. Crossing surface and ballast approaches appear clear from sand or debris. No apparent erosion or undermining in trackbed or edge of pavement.

*Track Approach Sightlines (Good Condition):* All track sightlines clear of large trees or other obstructions.

*Pedestrian Access and Curbing (Fair Condition):* Sidewalk is present on each side of both approaches to the crossing surface. No detectable warning pads are present at any of the sidewalk approaches to the crossing surface. The southeast sidewalk

approach appears to be deteriorating and not meeting ADA standards, as it appears relatively thin and to have been temporarily paved. Mountable curbing is present for all approaches. The southeast approach curbing appears to be deteriorating at the crossing surface.

- Replace south sidewalk with ADA compliant concrete sidewalk;
- Install pre-emption with intersection signals to clear queue for train arrival;
- Remove and replace stop bar and railroad crossing pavement markings;
- Install pedestrian gates at open sidewalks in three locations;
- Improve existing signal system for additional gates; and
- Install detectable warning pads for all sidewalk approaches.

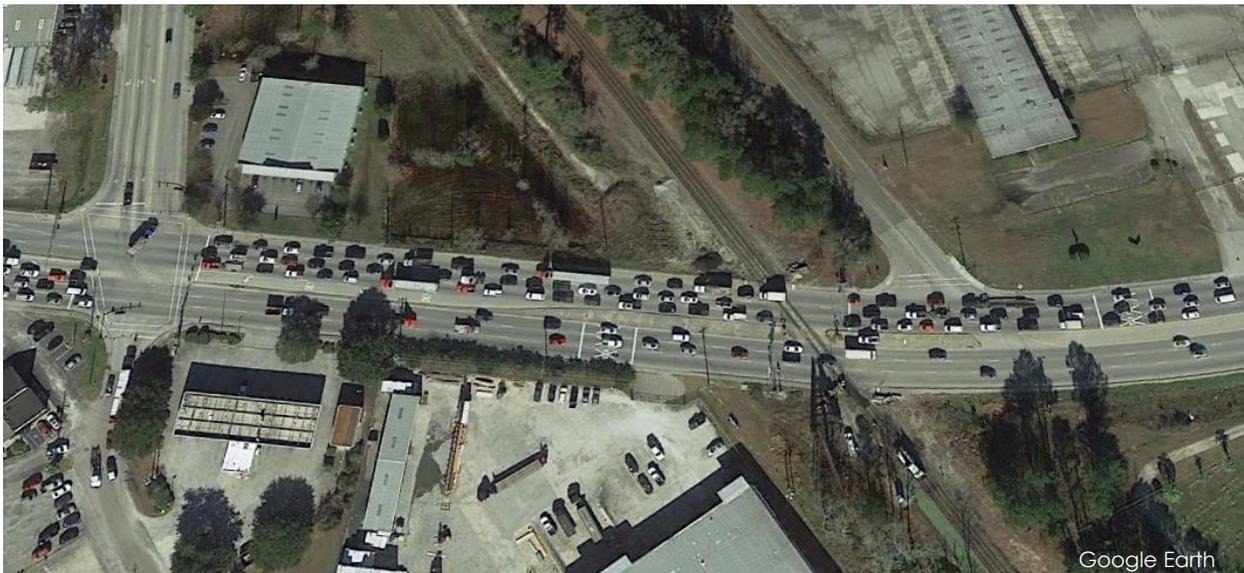
**Figure 22 - Ashley Phosphate Road Westbound Queuing**

- Inventory report date of 08/12/2019;
- Single Track Crossing;
- Westbound vehicles stopped at signalized intersection of Palmetto Commerce Parkway typically queue across crossing (Figure 22);

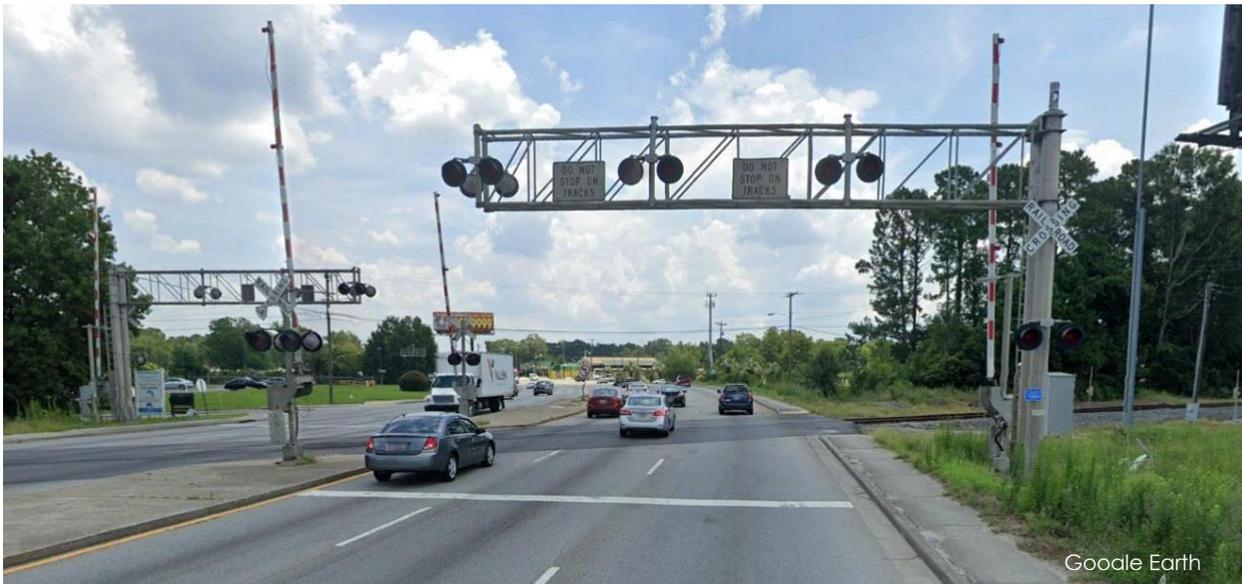
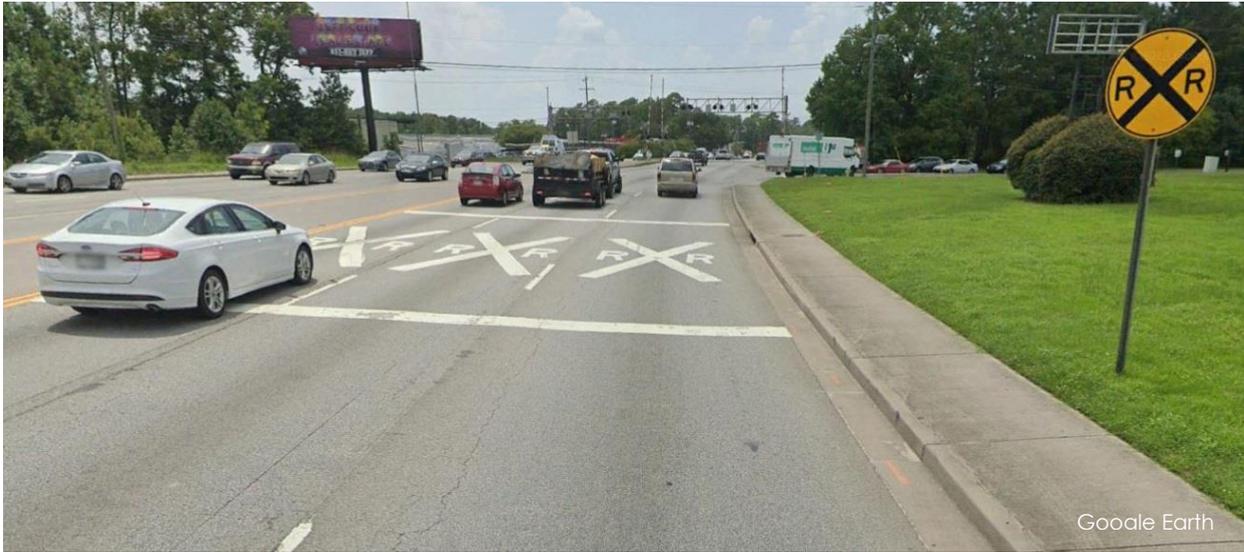
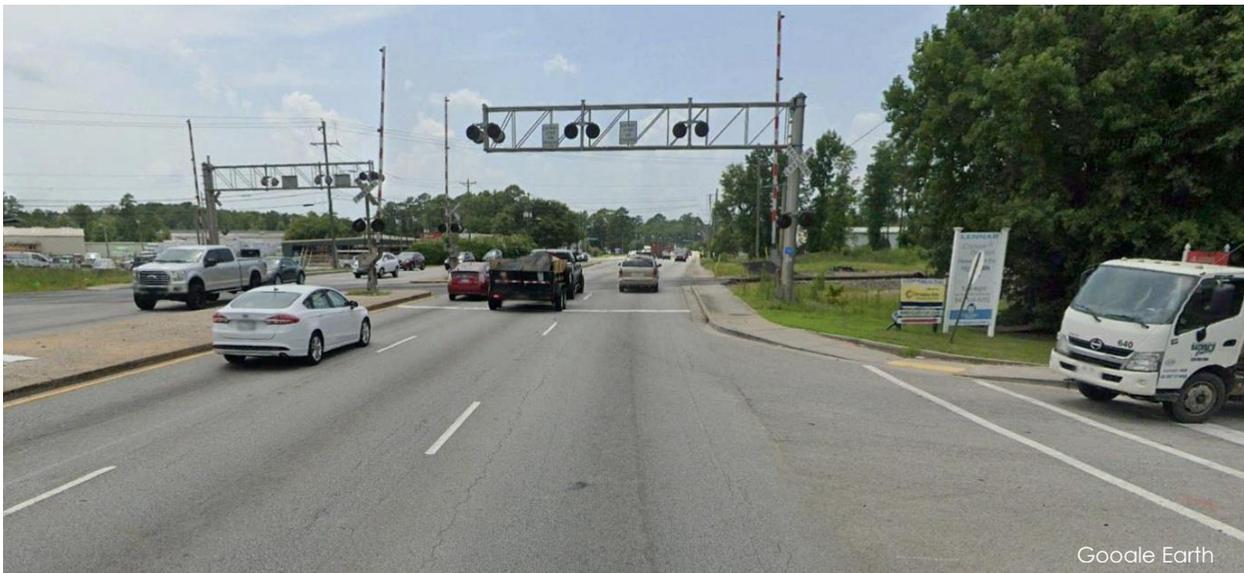
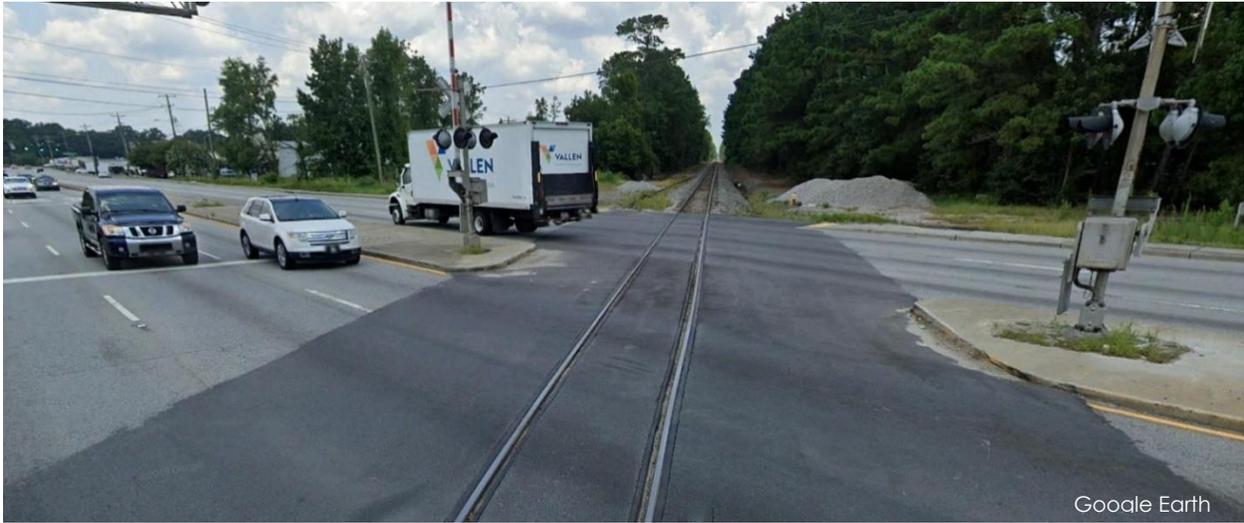
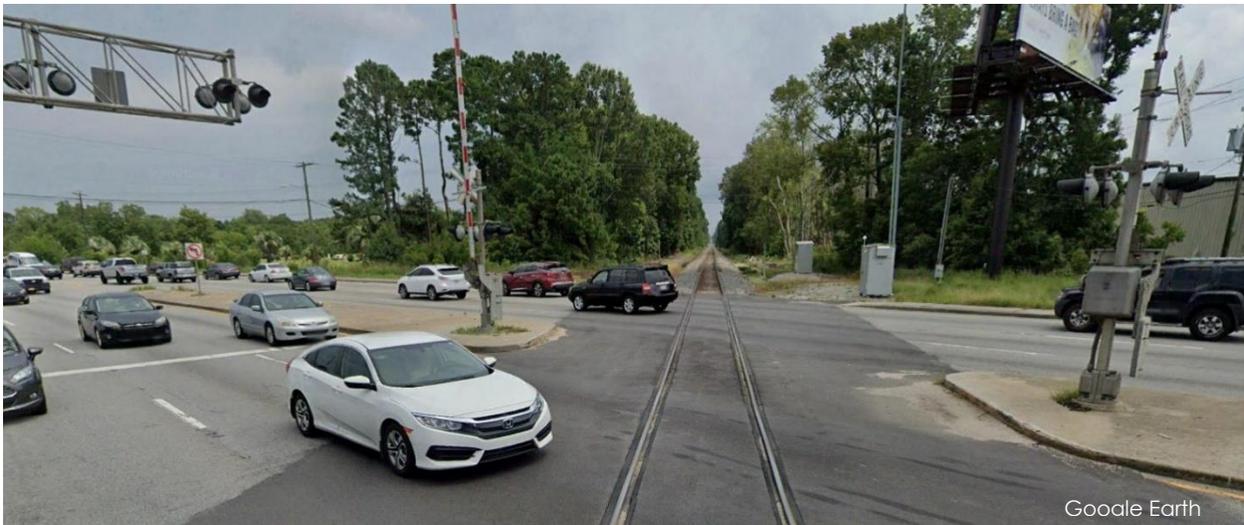
*Crossing Signal Equipment (Good Condition)*: Signalized with two-quadrant protection, cantilever signal masts and two-gate roadway protection for each approaching roadway (median and edge of roadway with sidewalk coverage). Sidewalks in opposite quadrants are not protected.

*Roadway Surface (Good Condition)*: Consists of asphalt and rubber flangeway filler, notably repaved recently as part of a railroad improvement project for this crossing. Approach pavement appears to be in good condition. Ashley Phosphate Road has a raised median; however, it appears to be mountable.

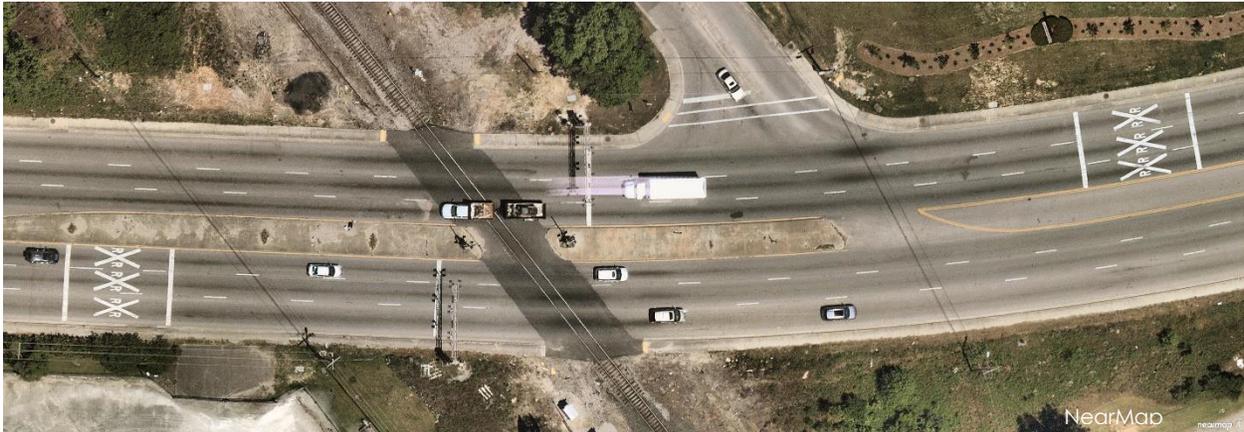
**Figure 29 - Ashley Phosphate Crossing Pavement Markings**

*Railroad Crossing Pavement Markings (Fair Condition)*: Pavement markings appear to be in good/fair condition. Stop Bars and railroad crossing markings are present on each approach Except for Southrail Road.

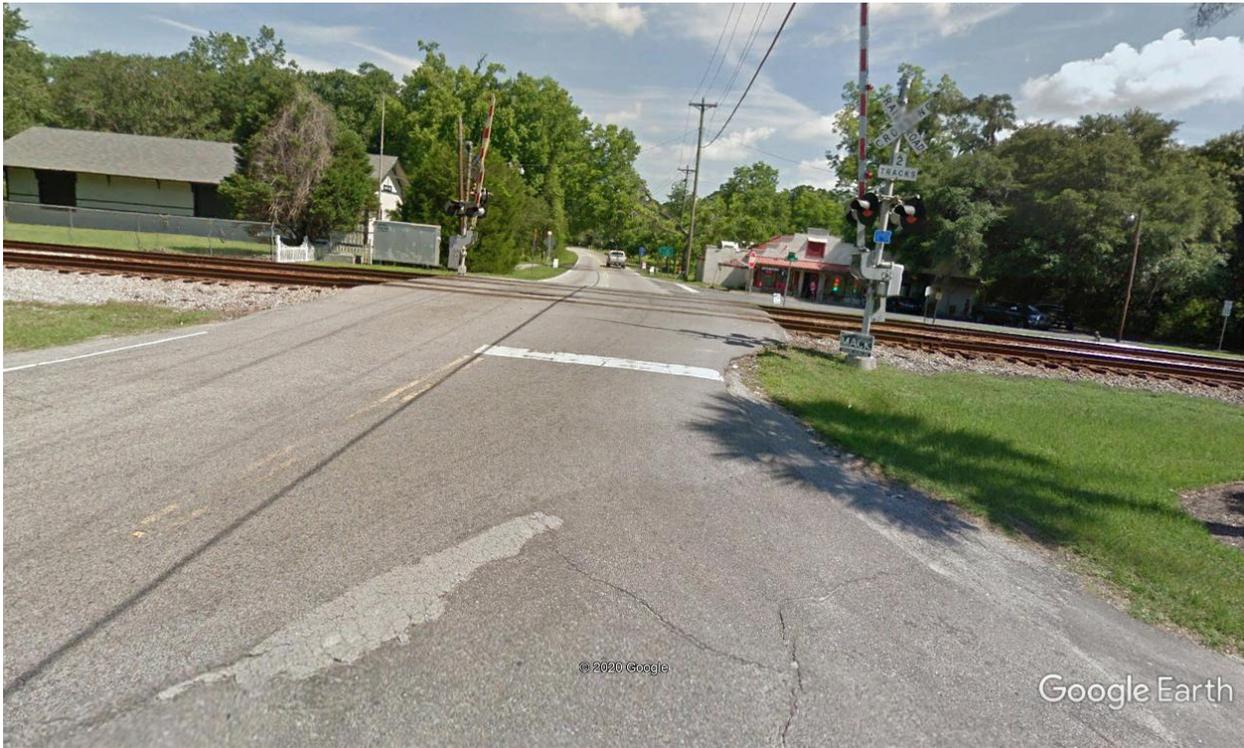
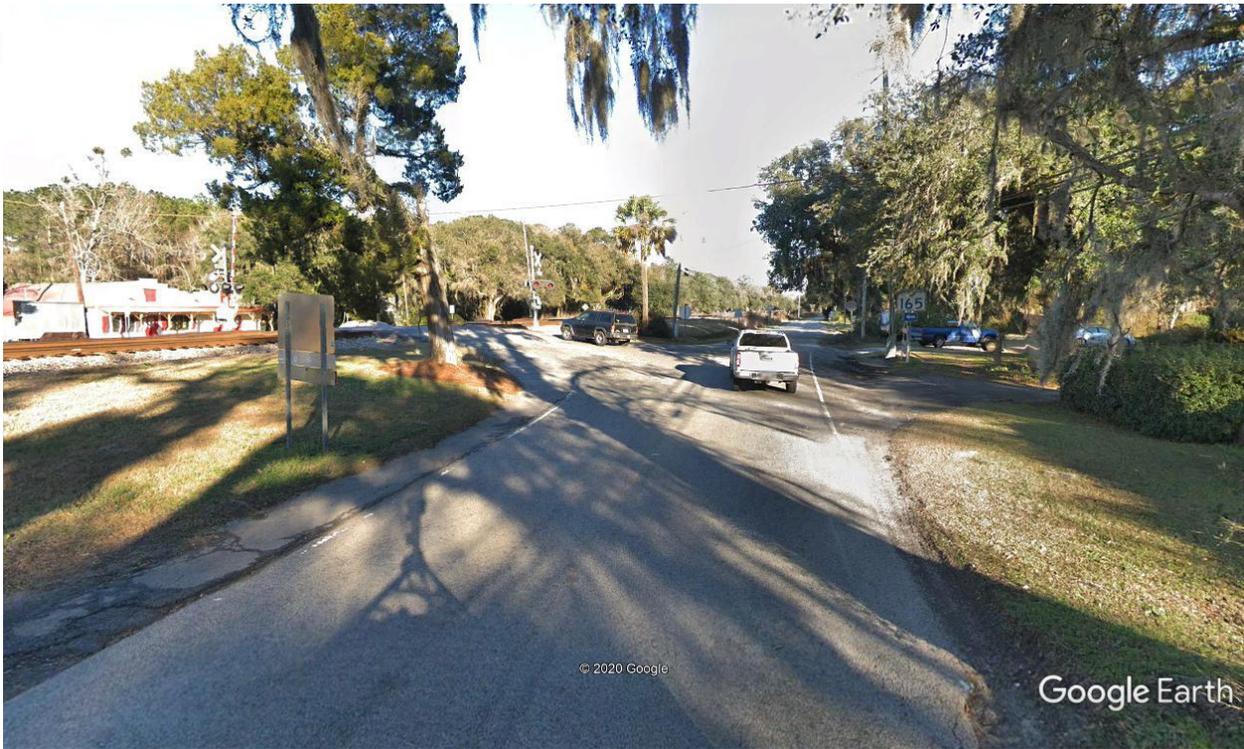
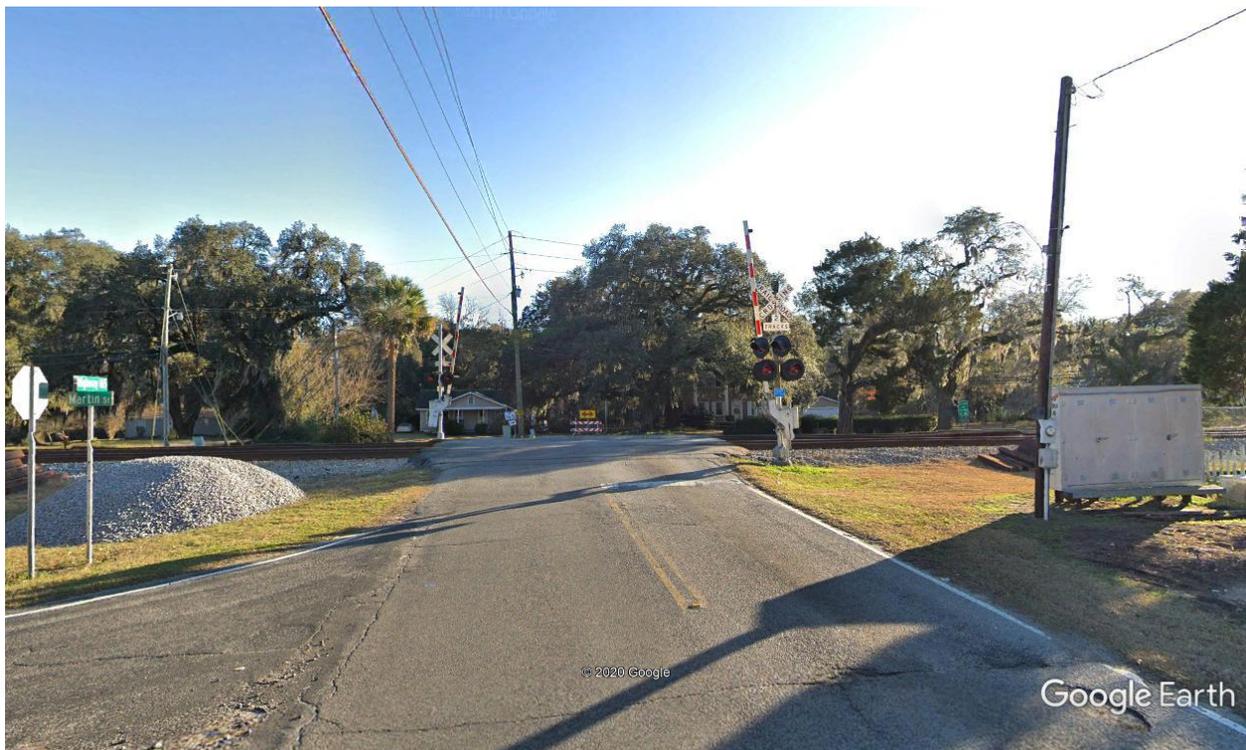
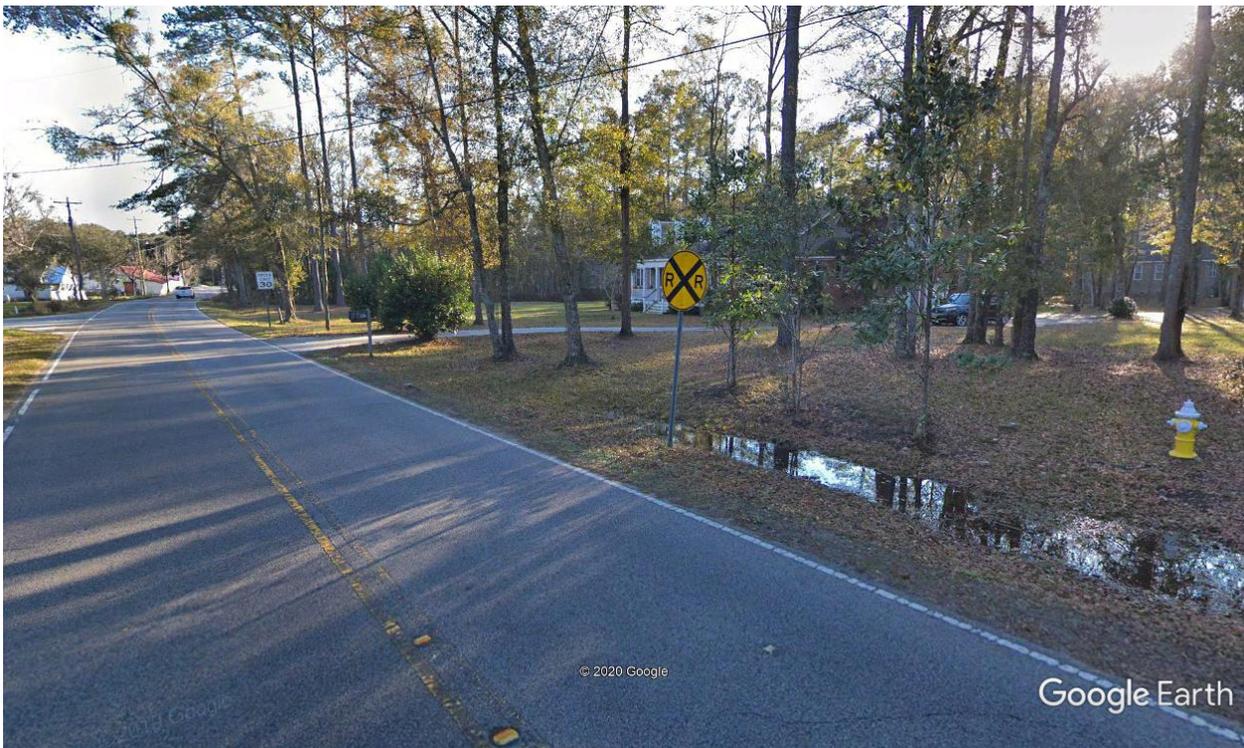
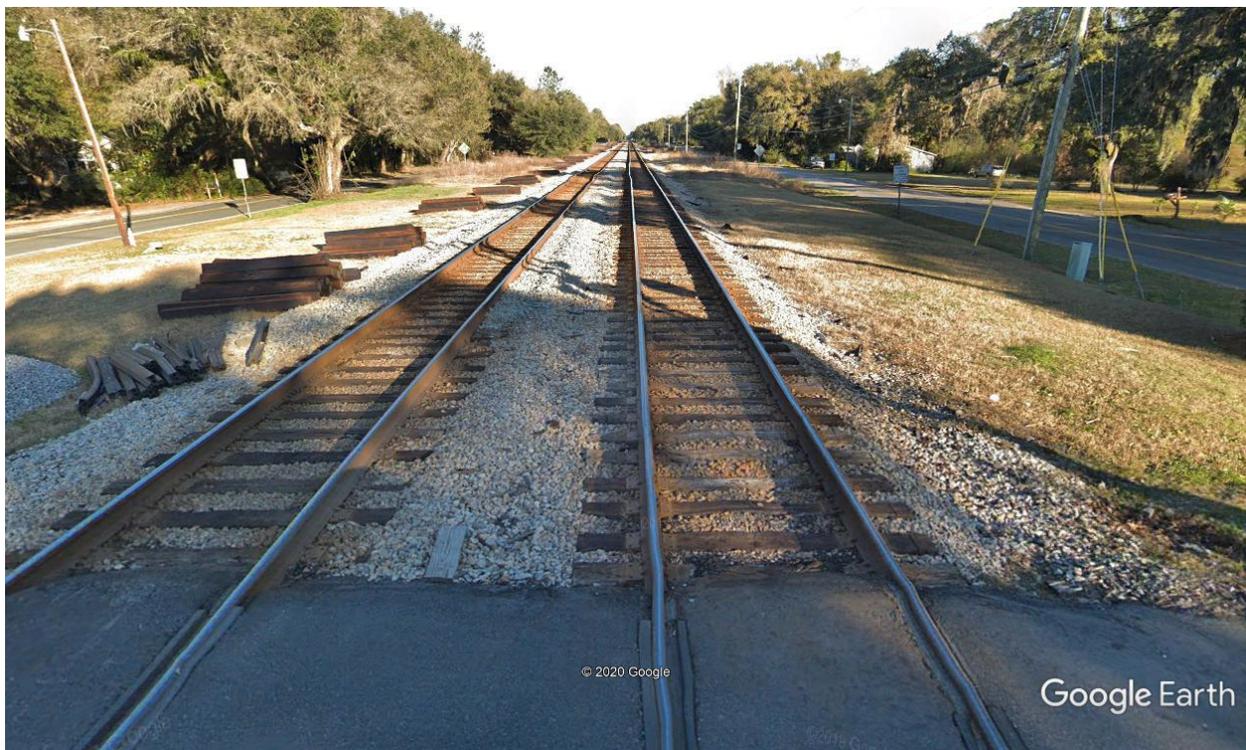
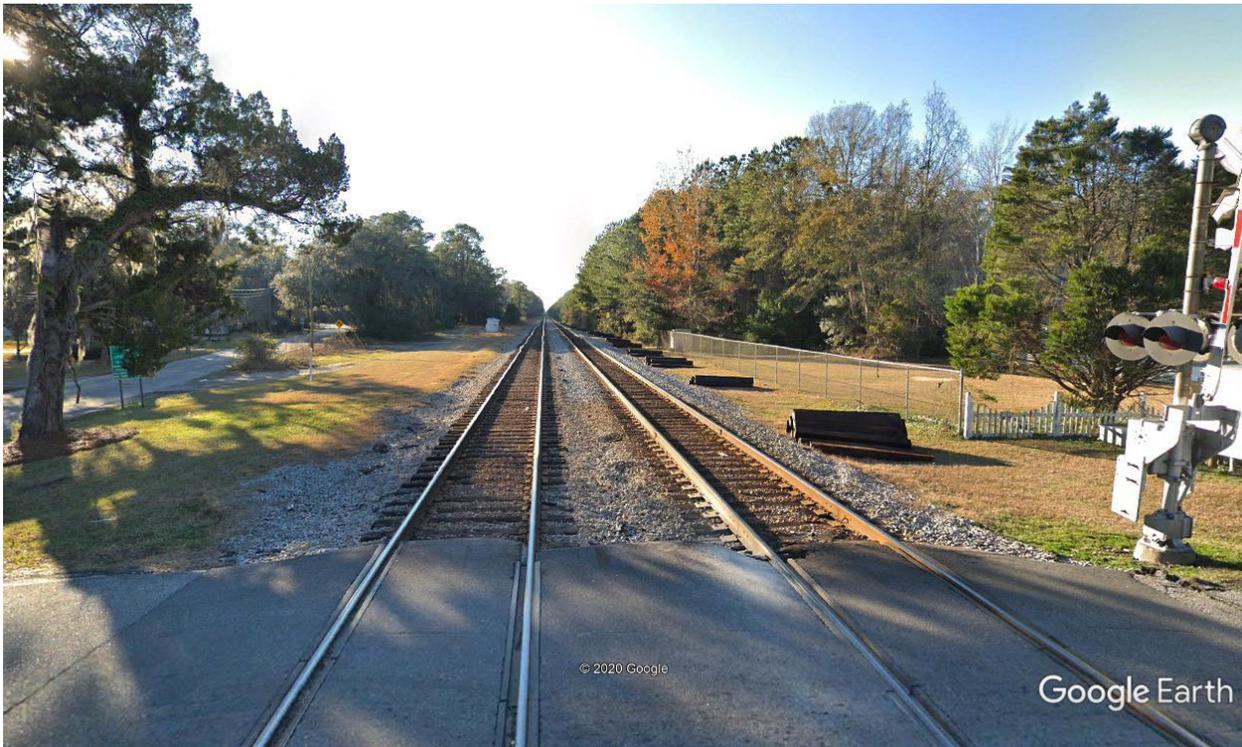
*Railroad Crossing Signs (Poor Condition):* Advanced warning sign present on Drayton Street (SC 165) east approach to the crossing (See Figure 5). Advance warning sign on SC 165 north approach is located far in advance of the crossing (approximately 700 feet), and approximately 300 feet in advance of the railroad crossing pavement marking (See Figure 38 & Figure 39). No advance warning signage is posted on Martin Street or the Drayton Street west approach to the crossing.

*Pedestrian Access and Curbing (Not Applicable):* Sidewalk and curbing is not present at the crossing surface and immediate approaches. No crosswalks or transitions are present to the crossing surface.

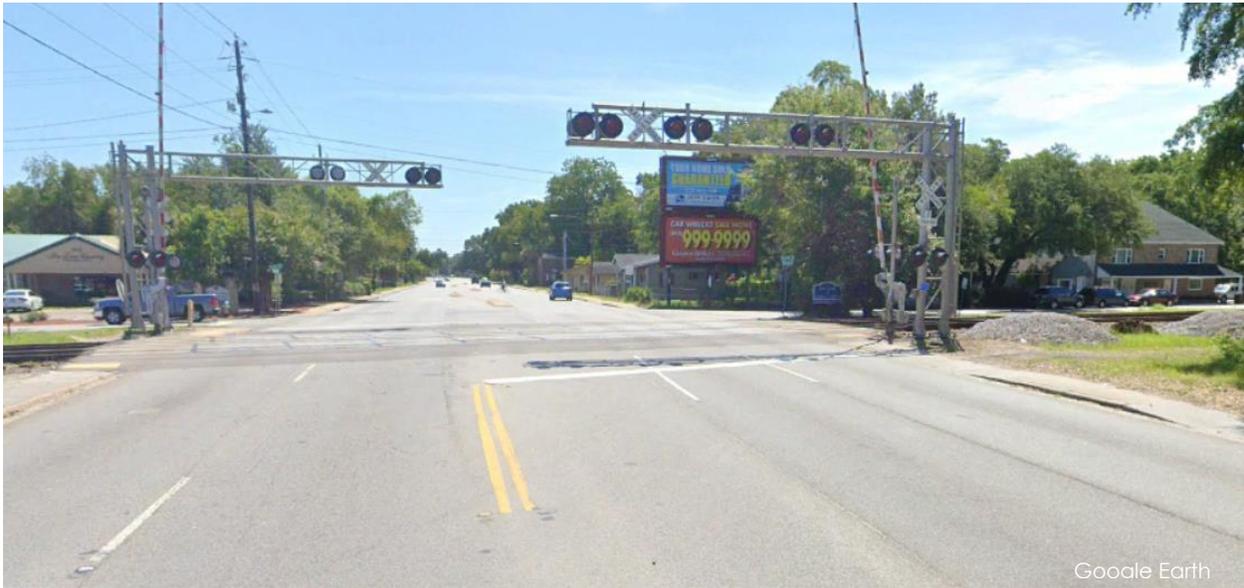
**Figure 44 - East Montague Avenue Crossing Looking East**

Crossing Signal Equipment (Good Condition): Two quadrant protection, cantilever signal masts with roadway and sidewalk protection for each approaching roadway. Gates are noticeably long and only located at the edge of roadway. Sidewalks are not protected in remaining quadrants.

*Track Approach Sightlines (Poor Condition):* The track sightlines for southwest and southeast quadrants are obstructed by large trees. Sightlines are clear of obstructions in the northwest and northeast roadway quadrants.

*Pedestrian Access and Curbing (Fair Condition):* Sidewalk is present on each side of the roadway and through the crossing surface. The southeast quadrant detectable warning pad is missing and the remaining detectable warning pads are present however all are located within the gated area with the northeast and southwest pads immediately below gates.

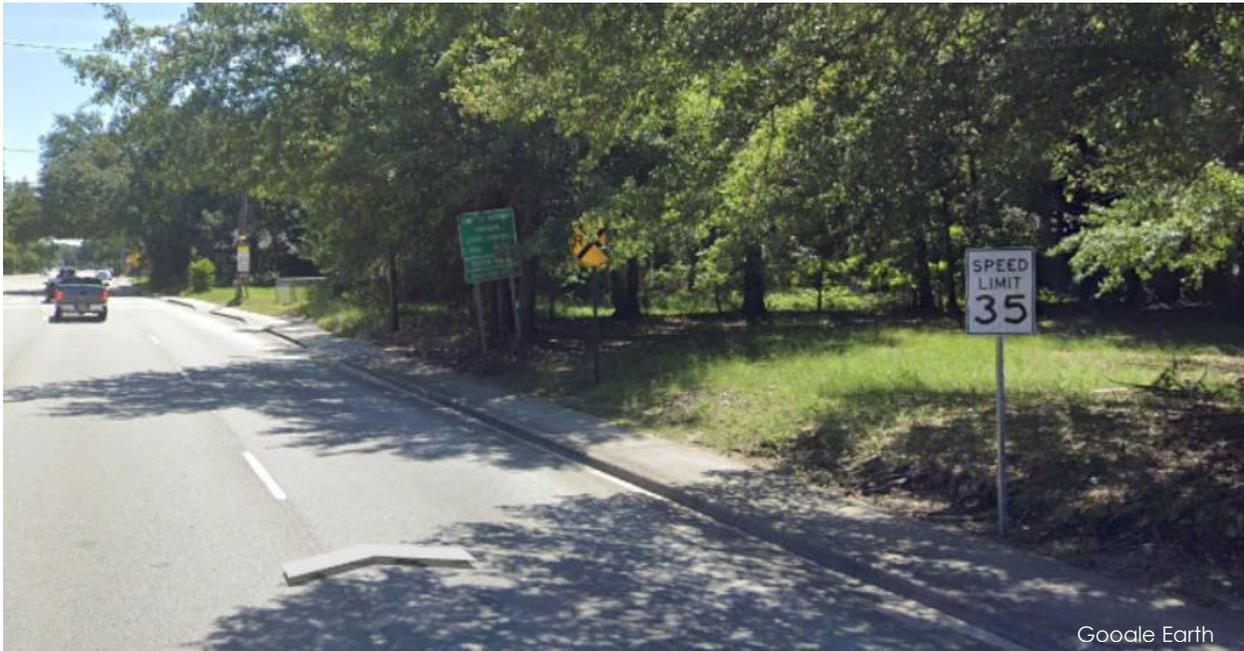
**Figure 48 - East Montague Avenue West Approach Advance Warning Sign Looking East**

*Railroad Crossing Signs (Good Condition):* Signs mounted on the cantilever signal masts at the crossing are in good condition and clearly visible. The west approach advance warning sign is obstructed by trees and is located 180 feet prior to railroad crossing pavement markings (See Figure 48). Prior to the crossing is an additional advance intersection warning sign, placed approximately 110 feet in advance of the crossing (See Figure 49). The east approach advance warning sign is clearly visible.

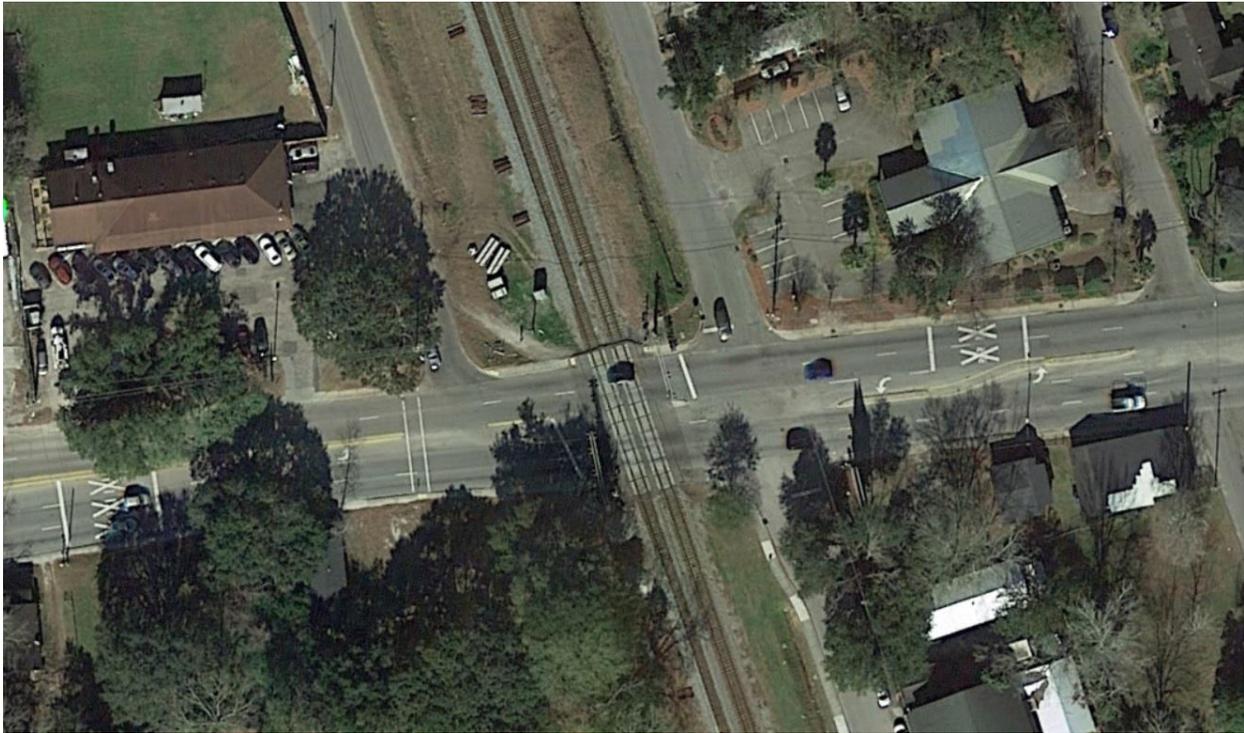
**Figure 50 - East Montague Avenue Pavement Markings**

*Railroad Crossing Pavement Markings (Fair Condition):* Stop bars and railroad crossing pavement markings appear to be in fair condition. Markings are in the early stages of cracking and scaling.

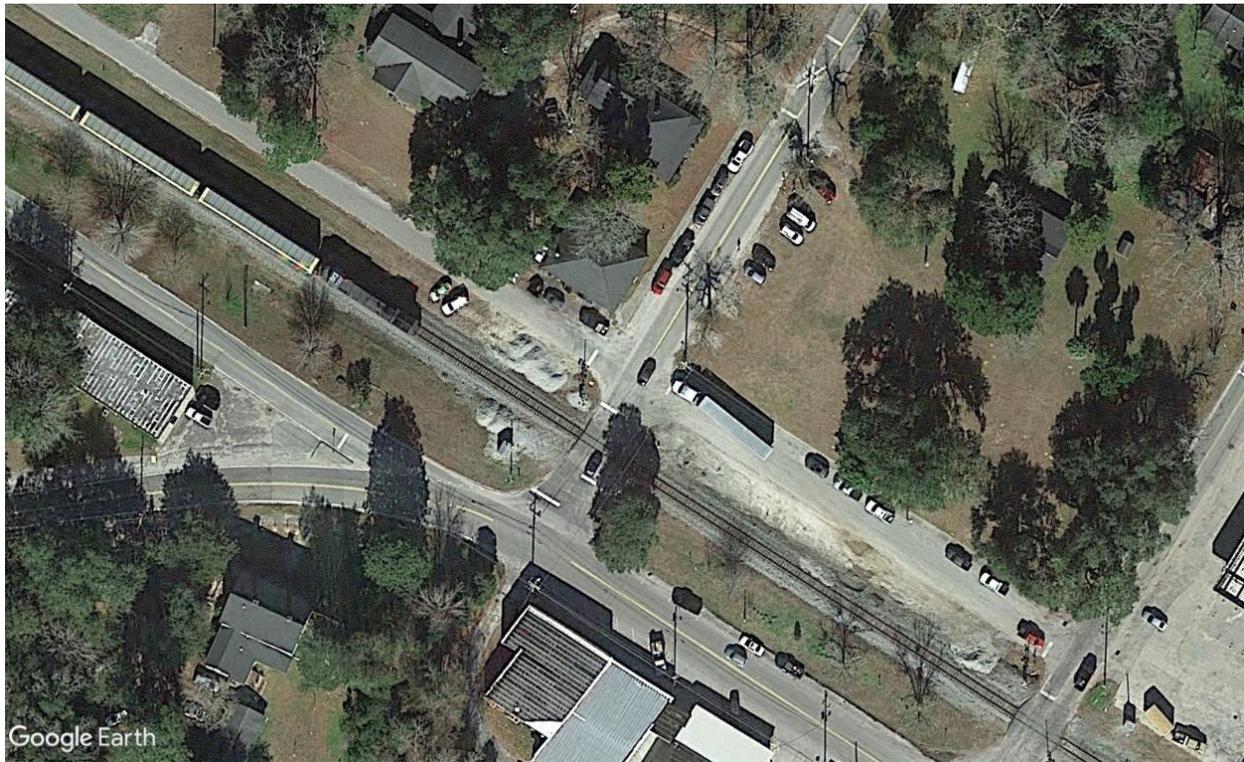
**Figure 51 - North Main Street Rail Crossing**

- Located in Ridgeville, SC, between N Railroad Avenue and S Railroad Avenue;
- Operated by Norfolk Southern Railway Company;
- FRA Crossing Inventory Number 721485N;
- Inventory report date of 06/01/2019;
- Single Track Crossing (Figure 51);
- Not located within a quiet zone; and
- 3 reported accidents between 2009 and 2019, incidents to note:
  - January 2018 – Train struck vehicle stopped on crossing – three railroad employees injured;
  - June 2012 – Train struck vehicle stopped on crossing – no injuries reported; and
  - October 2009 – Train struck concrete truck stopped on crossing – one highway user and railroad employee injured.

Due to the close proximity of the Church Street at-grade crossing, North Main being a secondary road crossing, and the accident history at North Main, it is recommended to close the North Main Street at-grade crossing. A planning level estimate for closing the at-grade crossing is shown in Table 9.

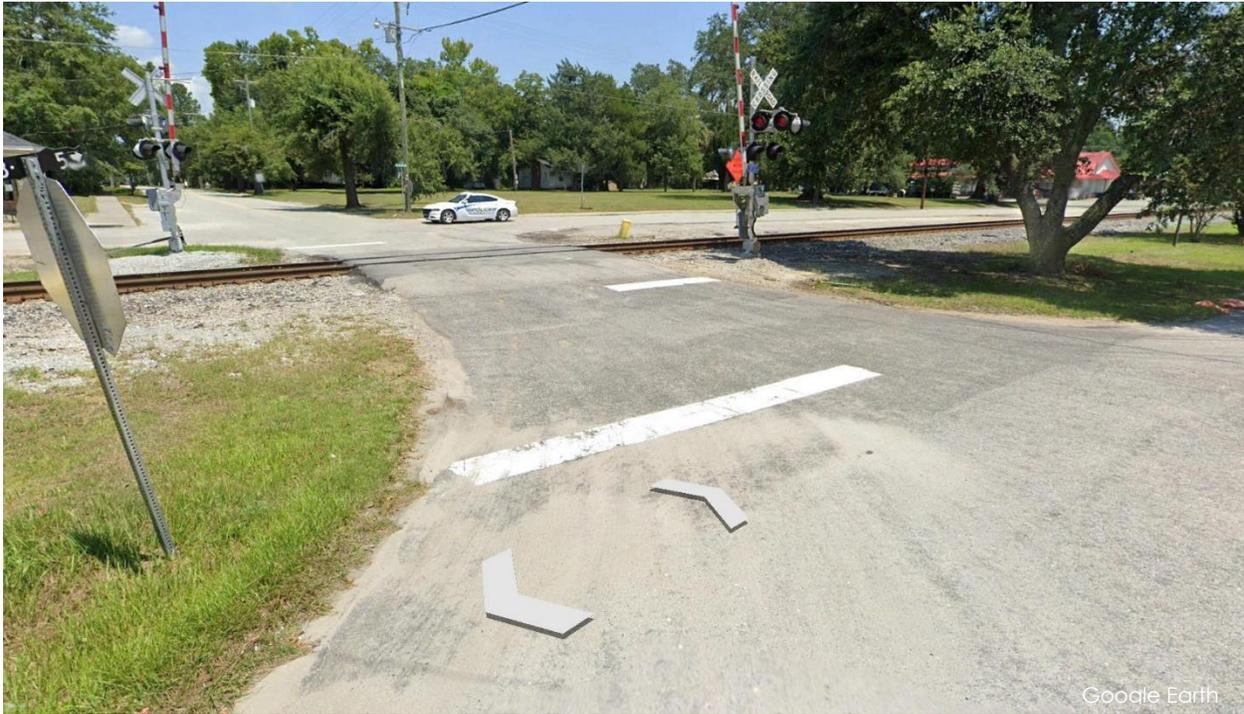
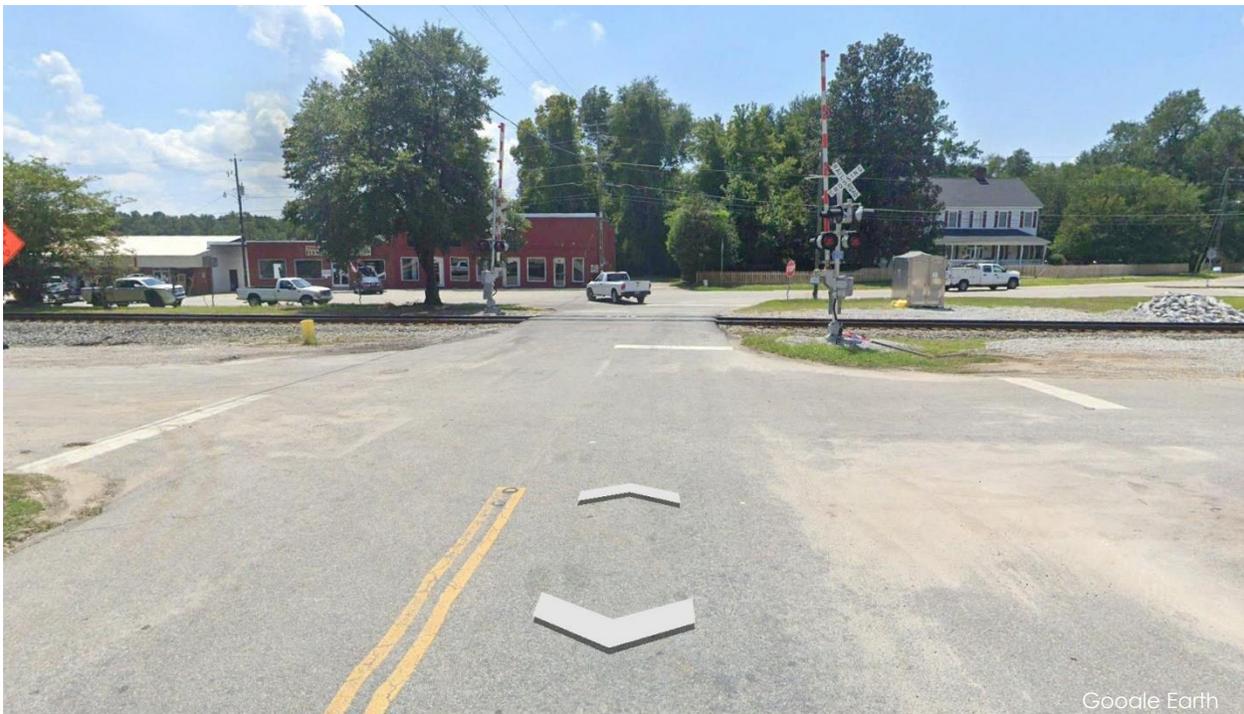
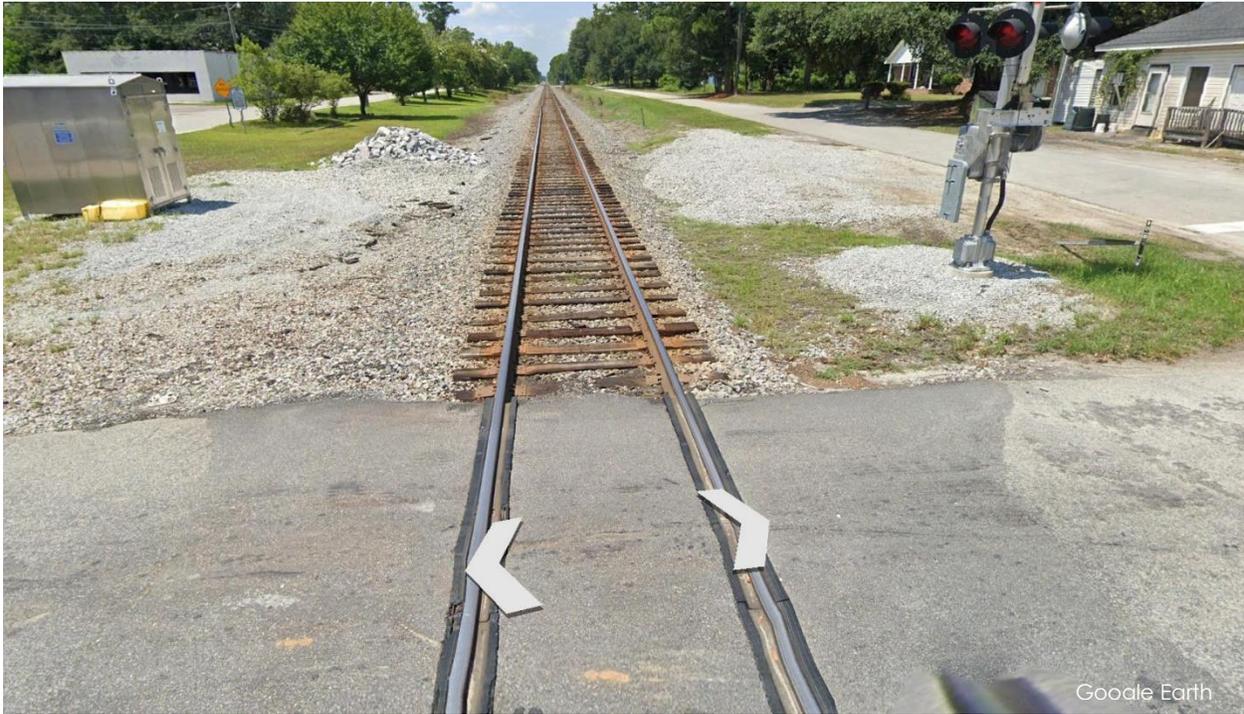
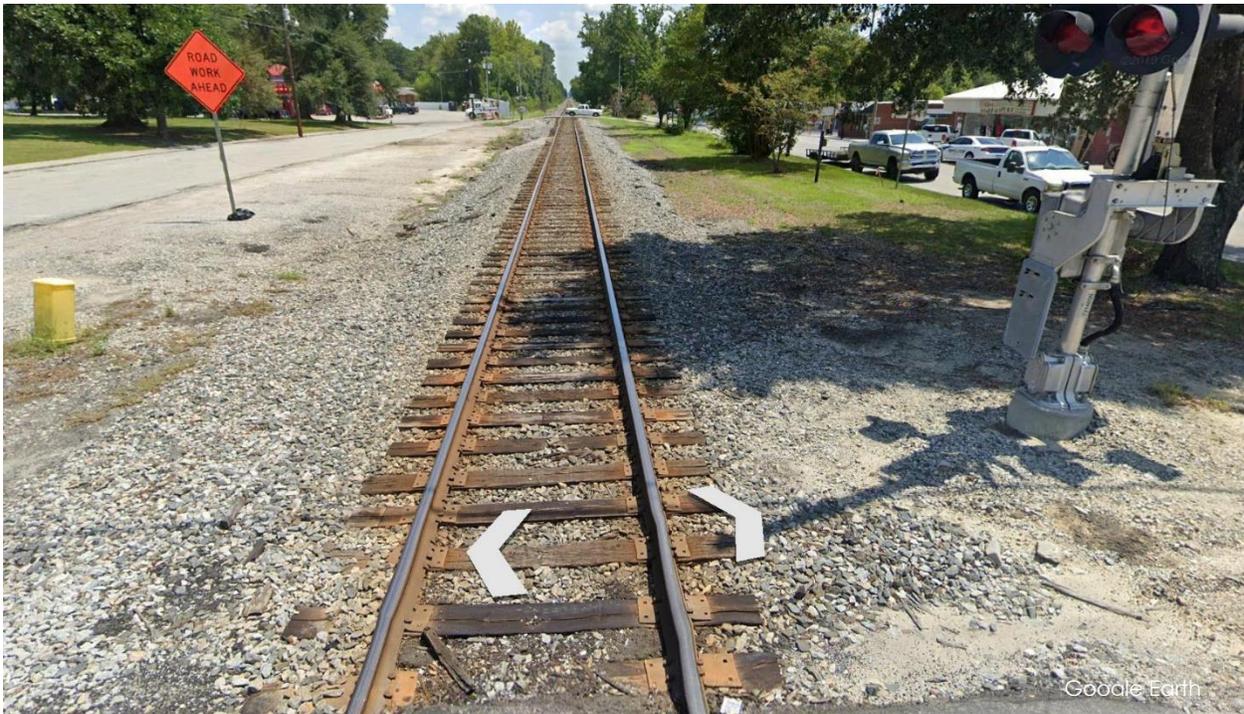
*Crossing Signal Equipment (Good Condition)*: Signalized with two-quadrant protection. Gates only extend over approaching lanes. No sidewalks present at this crossing.

*Roadway Surface (Fair Condition)*: Consists of asphalt and rubber flangeway filler. The Rubber flangeway filler appears to be deteriorating and has pockets of sand and debris throughout the crossing surface. Also appears to be scrapes and low clearance drag marks across the crossing surface.

*Railroad Crossing Signs (Poor Condition)*: Advance crossing warning sign is only posted on the North Main Street north approach and appears to be unclean and tilted away from the roadway. No advance warning signage is posted on either N Railroad Avenue or S Railroad Avenue.

*Railroad Crossing Pavement Markings (Poor Condition)*: Pavement markings appear to be in fair/poor condition with cracking and deterioration. Advance warning pavement markings are not present on N Railroad Avenue or S Railroad Avenue.
