# APPENDIX G

Technical Memorandum

## Rail Assessment and Recommendations

January 2022

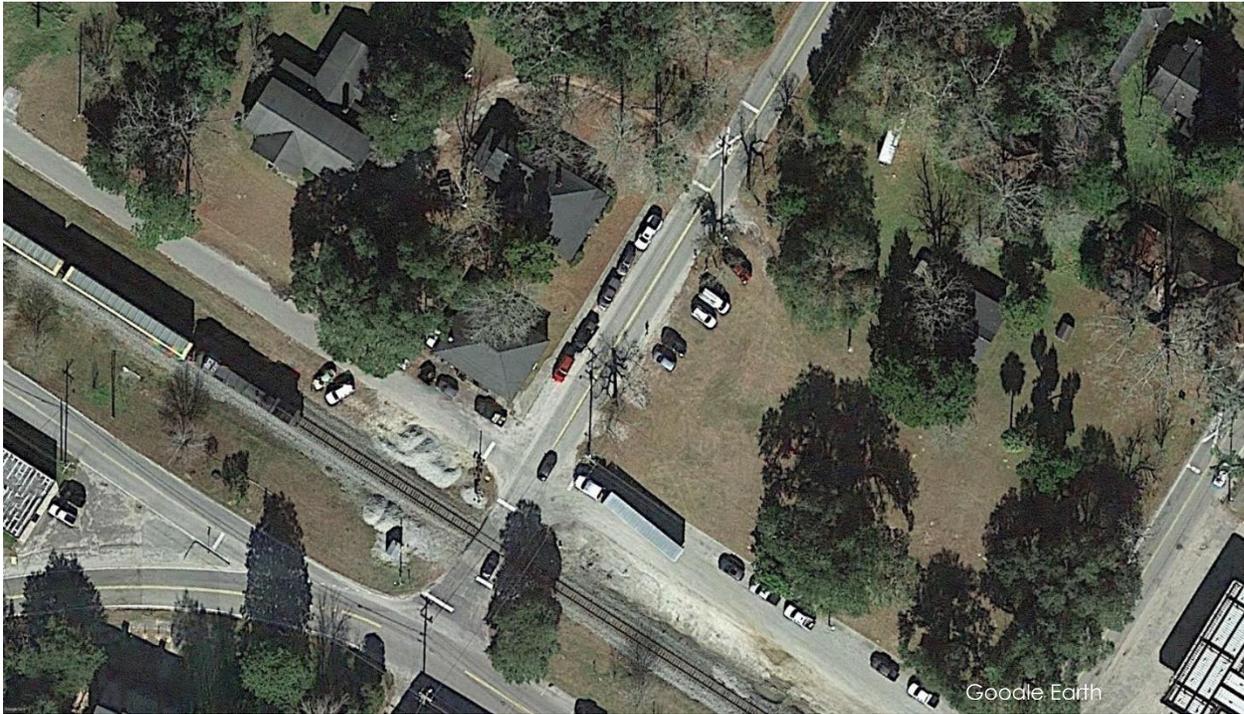
**Figure 56 - North Main Street Crossing Pavement Markings**

*Railroad Crossing Pavement Markings (Poor Condition)*: Pavement markings appear to be in fair/poor condition with cracking and deterioration. Advance warning pavement markings are not present on N Railroad Avenue or S Railroad Avenue.
